# NAGOYA UT-108UV - UHF - After mag mount repair

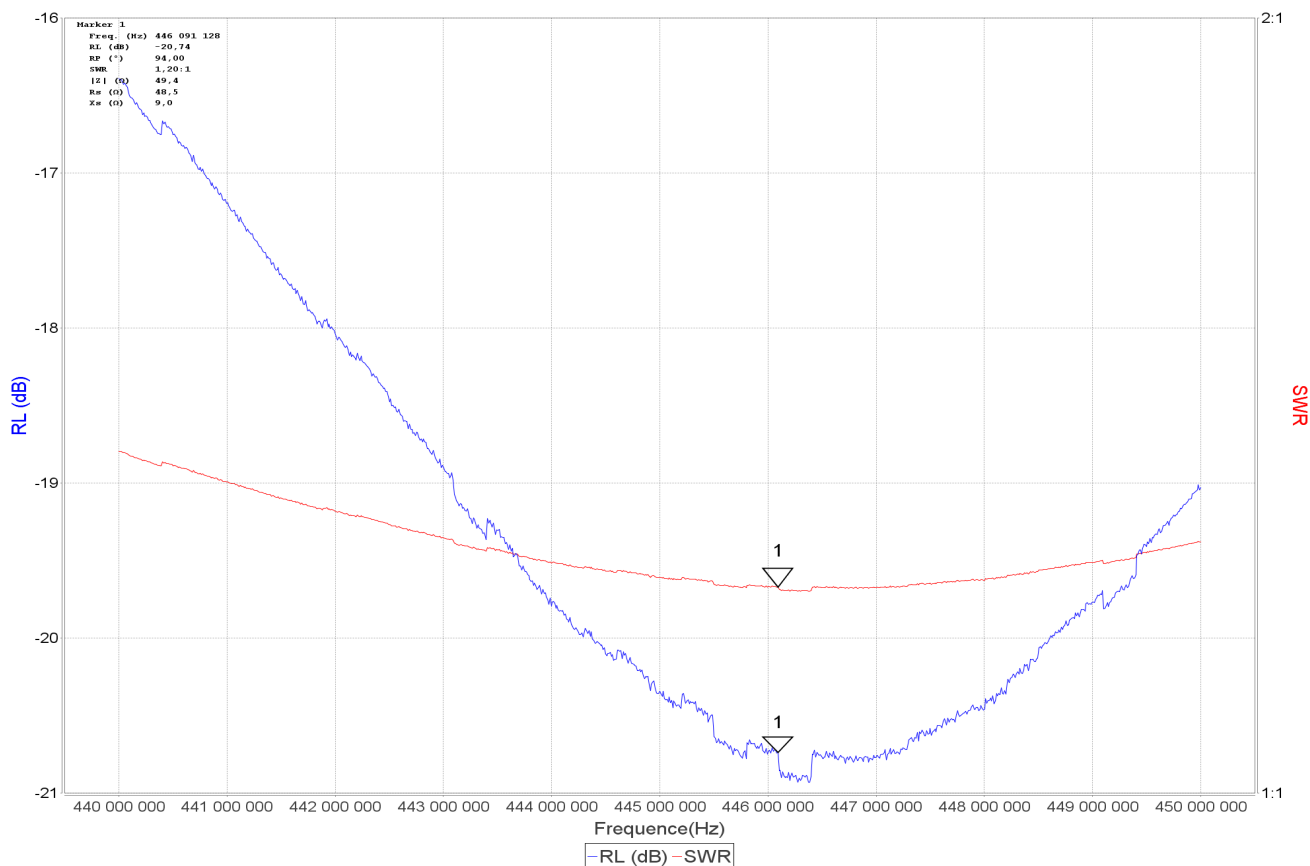
Marque ur	Freq. (Hz)	RL (dB)	RP (°)	Z  (Ω)	Rs (Ω)	Xs (Ω)	Theta	SWR
1	446 091 128	-20,74	94,00	49,4	48,5	9,0	10,5	1,20:1

Date: 01/07/17 10:27  
 Mode: Reflexion  
 Analyser: miniVNA Tiny / mini radio solutions - miniVNA Tiny  
 Scan  
   Start: 440000000 / 440 000 000  
   Stop: 449999885 / 449 999 885  
   Samples: 917  
   Overscan: 9  
 Calibration  
   Samples: 10000  
   Overscan: 0  
   File: ---  
 User: 14FRS677  
 Headline: NAGOYA UT-108UV - UHF - After mag mount repair  
 Port extension len: <not set>m  
 Port extension vf: <not set>
