# NAGOYA UT-108UV - UHF - After mag mount repair

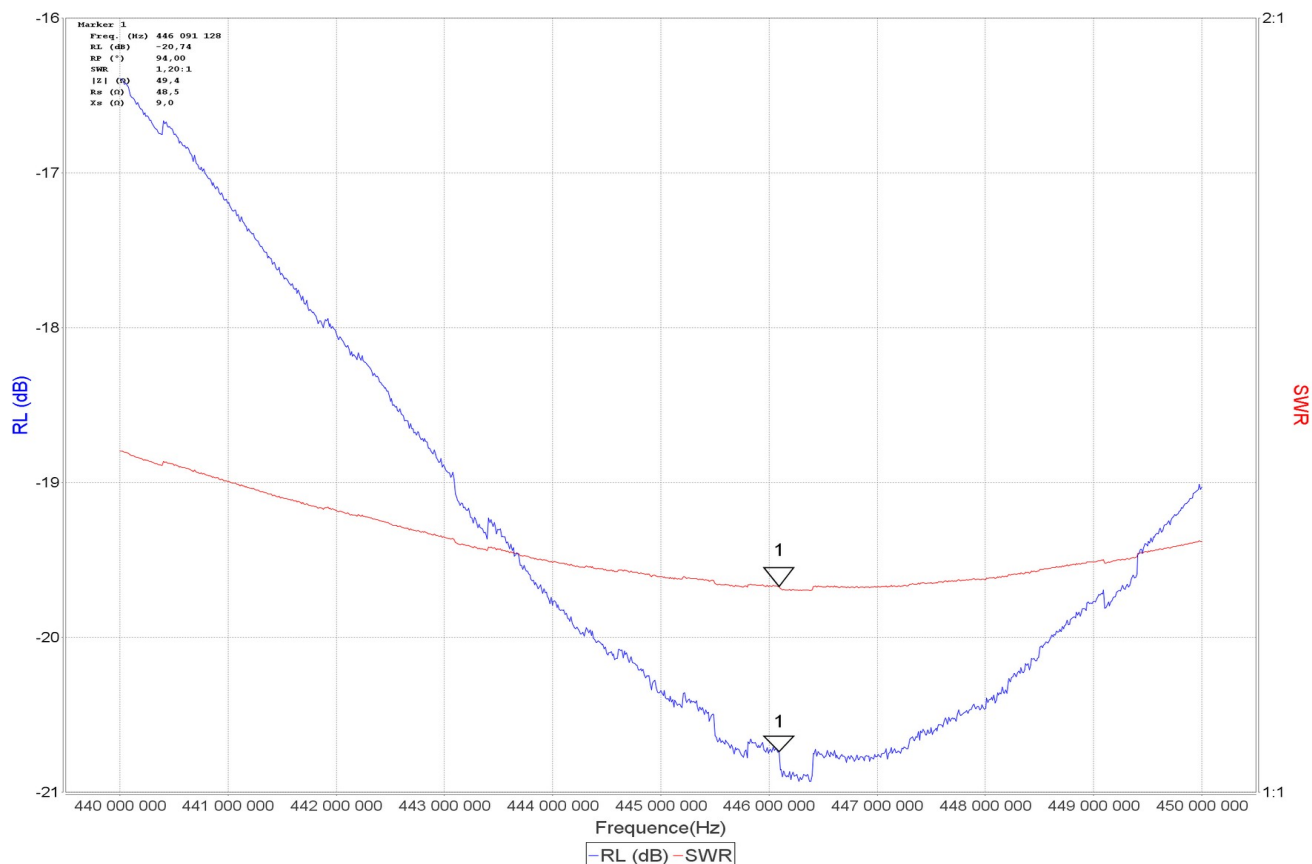
| Marque<br>ur | Freq. (Hz) | RL (dB) | RP (°) | Z (Ω) | Rs (Ω) | Xs (Ω) | Theta | SWR |
| 1 | 446 091 128 | -20,74 | 94,00 | 49,4 | 48,5 | 9,0 | 10,5 | 1,20:1 |

Analyser: miniVNA Tiny / mini radio solutions - miniVNA Tiny

Start: 440000000 / 440 000 000

Stop: 449999885 / 449 999 885
