# NAGOYA UT-108UV - VHF - After mag mount repair

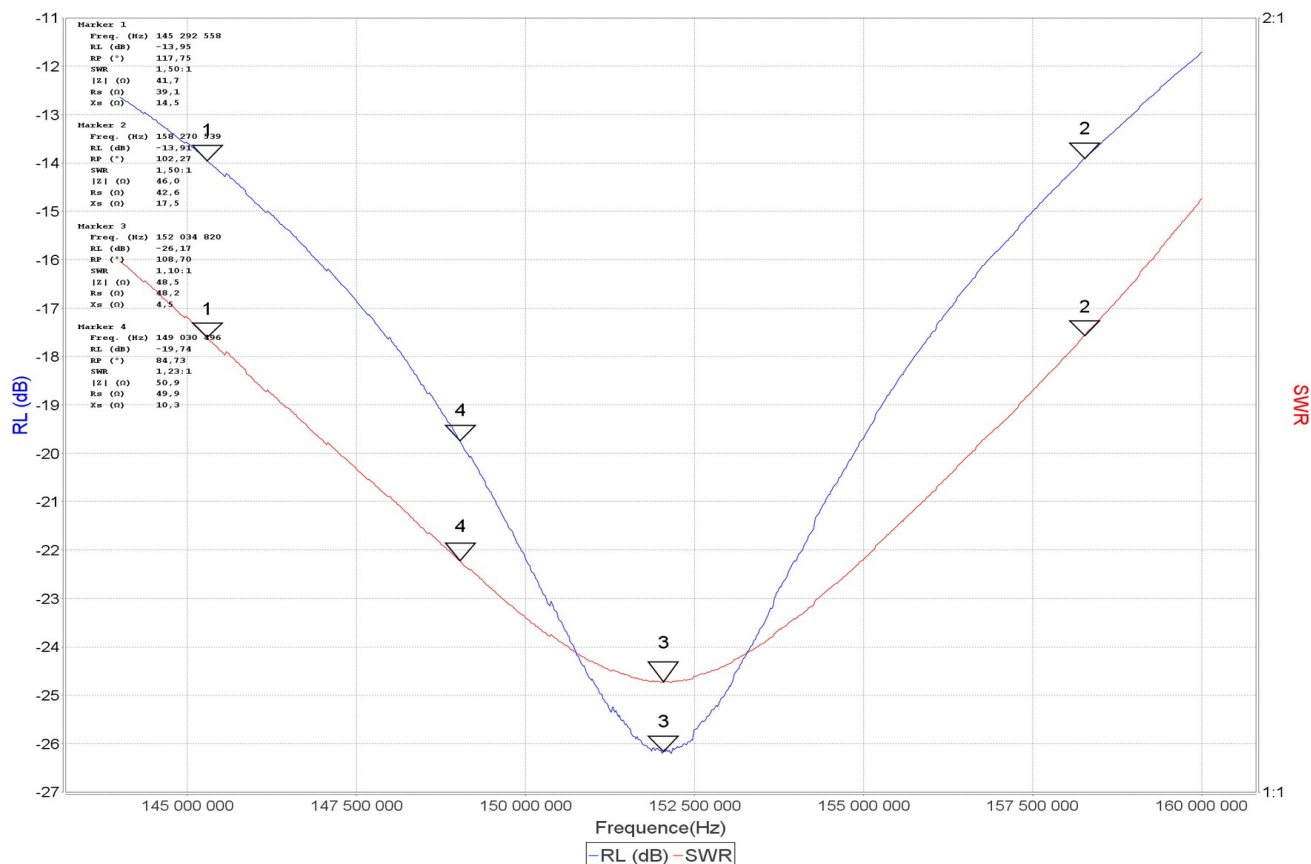
| Marque<br>ur | Freq. (Hz) | RL (dB) | RP (°) | Z (Ω) | Rs (Ω) | Xs (Ω) | Theta | SWR |
| 1 | 145 292 558 | -13,95 | 117,75 | 41,7 | 39,1 | 14,5 | 20,3 | 1,50:1 |
| 2 | 158 270 539 | -13,91 | 102,27 | 46,0 | 42,6 | 17,5 | 22,3 | 1,50:1 |
| 1-2 | 12 977 981 | 0,04 | 15,49 | 4,3 | 3,5 | 3,0 | 0,0 | --- |
| 3 | 152 034 820 | -26,17 | 108,70 | 48,5 | 48,2 | 4,5 | 5,3 | 1,10:1 |
| 4 | 149 030 496 | -19,74 | 84,73 | 50,9 | 49,9 | 10,3 | 11,7 | 1,23:1 |

Mode: Reflexion

Analyser: miniVNA Tiny / mini radio solutions - miniVNA Tiny

Start: 144000000 / 144 000 000

Stop: 159999816 / 159 999 816
