NAGOYA UT-108UV - VHF - After mag mount repair

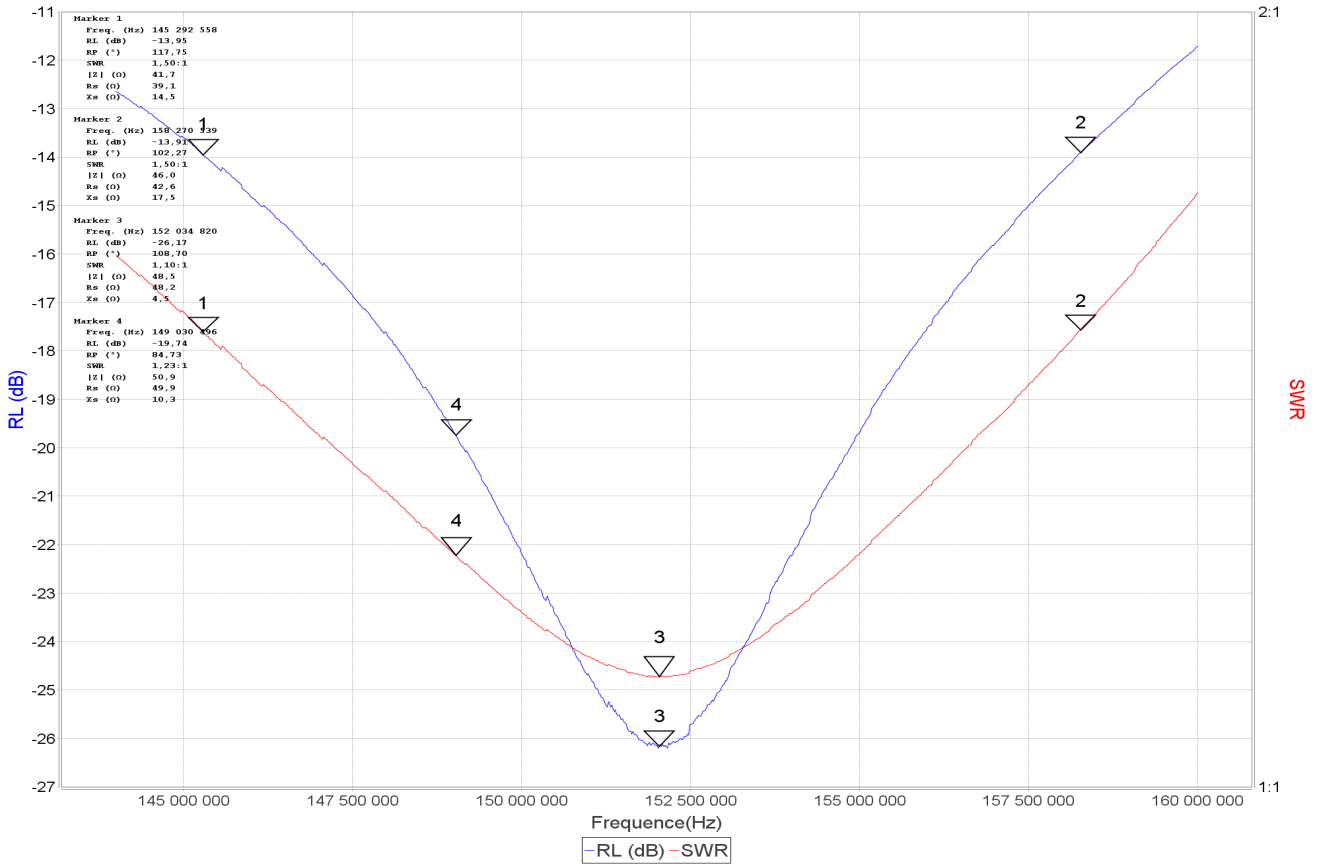
Marqueur	Freq. (Hz)	RL (dB)	RP (°)	Z (Ω)	Rs (Ω)	Xs (Ω)	Theta	SWR
1	145 292 558	-13,95	117,75	41,7	39,1	14,5	20,3	1,50:1
2	158 270 539	-13,91	102,27	46,0	42,6	17,5	22,3	1,50:1
1-2	12 977 981	0,04	15,49	4,3	3,5	3,0	0,0	---
3	152 034 820	-26,17	108,70	48,5	48,2	4,5	5,3	1,10:1
4	149 030 496	-19,74	84,73	50,9	49,9	10,3	11,7	1,23:1
